**IMPROVED MANUFACTURING METHOD FOR PROCESSES  
FOR SUPER FINISHED SPUR AND HELICAL GEARS**

**Final Report**

**Prepared by  
CURTISS-WRIGHT CORPORATION  
Wood-Ridge, New Jersey 07075**

**for  
U.S. ARMY AVIATION SYSTEMS COMMAND  
P.O. BOX 209  
ST. LOUIS, MISSOURI 63166**

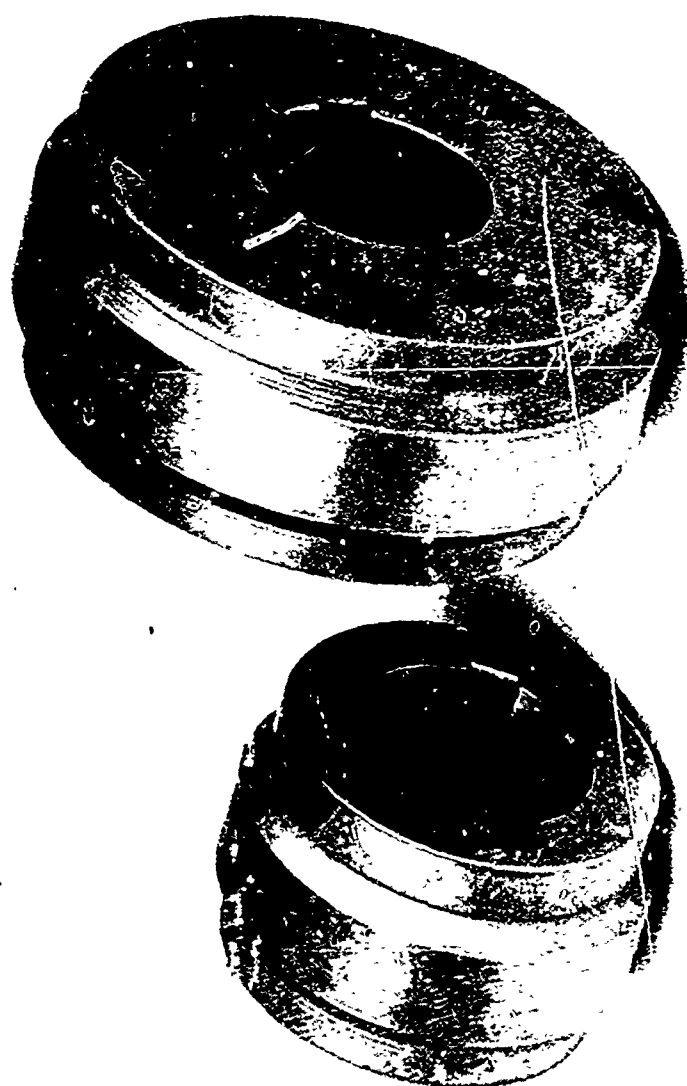
Figure 2. Test Rollers

The rollers as fabricated for this program are described dimensionally and defined in Table I. A typical set of driven and driver rollers is shown in Figure 2. Rollers were designed to be compatible with the Buckingham rig used for this testing. Table II shows the operating parameters utilized in the testing.

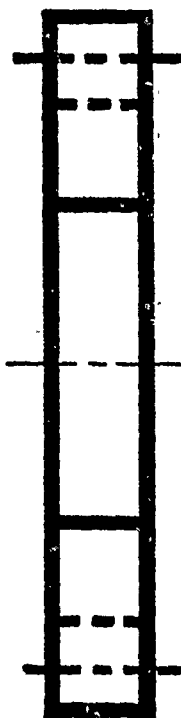
Copper Plate all over per 2418-21.  
Thickness of copper plate .0005 - .0012.  
Heavy lines denote surfaces to be  
copper plated.
